# **Alternative Bank Protection Methods for Puget Sound Shorelines**

Shorelands and Environmental Assistance Program  
Washington Department of Ecology  
Olympia, Washington

Publication # 00-06-012

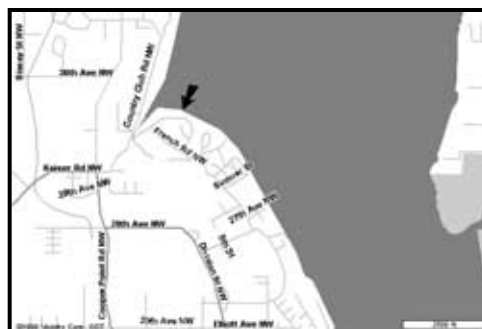
The Baum house is situated at the top of a very steep bluff on the west shore of Budd Inlet (Olympia, WA). The site is fronted by 255' of shoreline in a relatively low energy environment. The house was build circa 1930 and the present owner bought it approximately two years ago (1997). The house is situated on a nearly vertical bluff that was masked

by a 12-18" thick mat of Old English Ivy. The toe of the slope was faced with a 30-year-old timber bulkhead that was failing. Before the project began the driveway ran parallel to the shore between the house and the edge of the bluff. The homeowner noticed tension cracks in the driveway, which motivated him to have the slope stabilized.

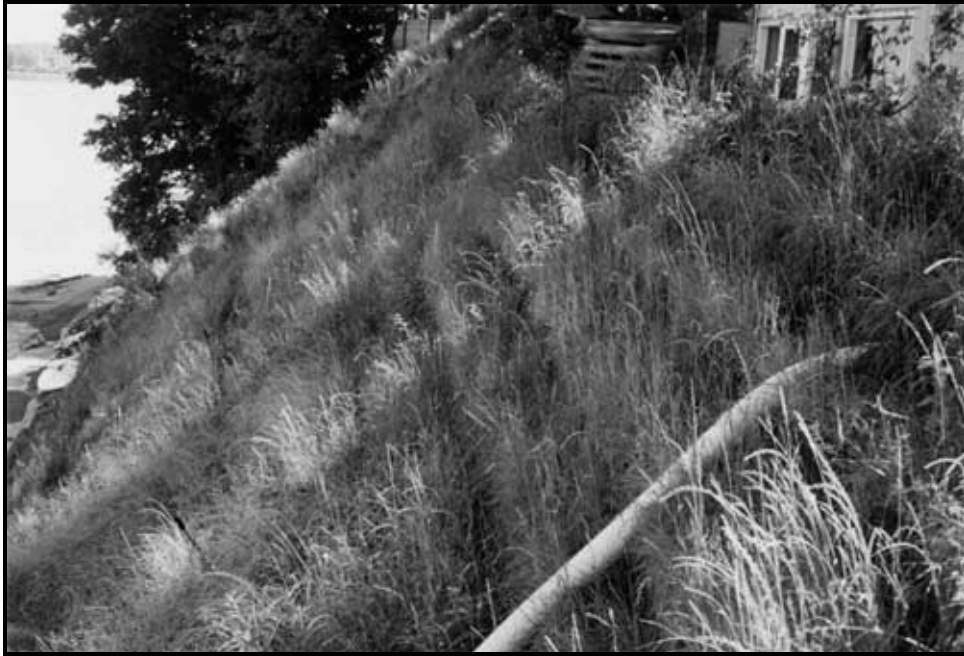
Figure 1. Vegetative slope stabilization. The bands of vegetation correspond to individual geogrid lifts. The hose in the foreground is part of new drainage system and flows into a diffuser behind the bulkhead.

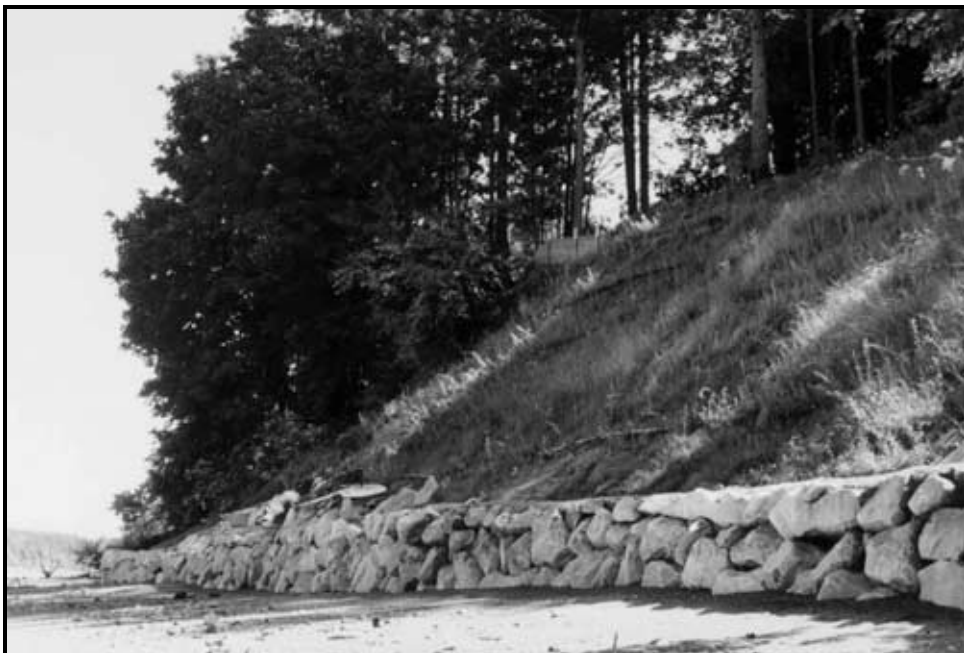
Figure 2. View from the beach. The lift layers can be seen. The slope is approximately 1H:1V, compared to its original near-vertical pre-construction state. The bluff is 30+ feet tall (the rock bulkhead is 5-6 feet high).

The old timber bulkhead was removed and replaced with a new 5' rip-rap bulkhead (6V:1H) of 6-man rock. It is 6' deep, backfilled with quarry spall and keyed into the beach 2.5-3.5 feet. After the rock was installed, pea gravel was added to the beach in front of the wall to improve the habitat for fish spawning. This was completed in the last week of August 1999 and some trail construction had yet to be completed in early September 1999.

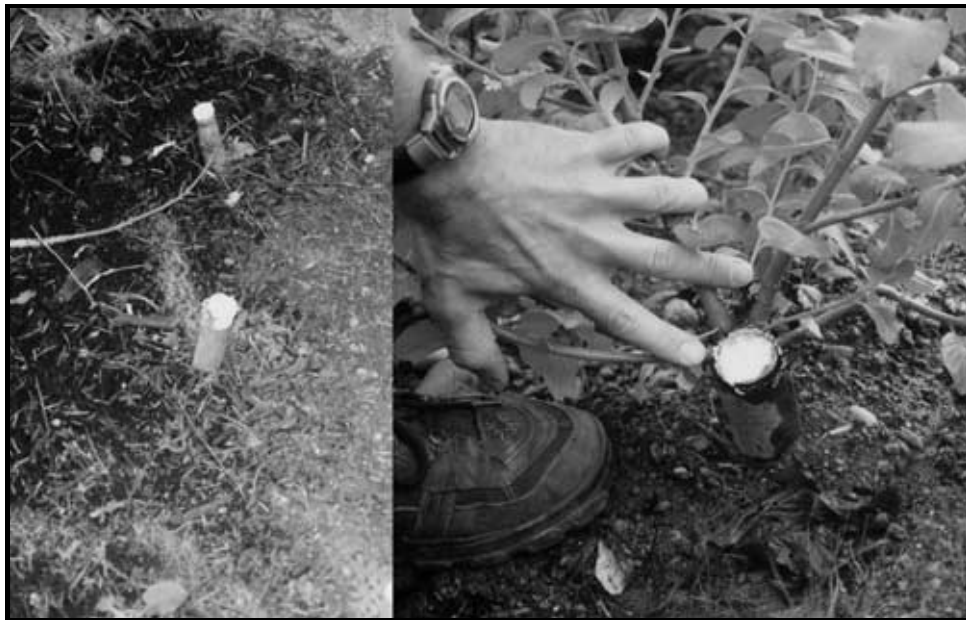
Figure 4. Live staking. When willow stakes are installed there is no growth - just a 1.5" portion of a 2-foot stake driven into the substrate. Four months later, vigorous growth has begun to secure soils in place.

b) Live staking – Cuttings of three willow and dogwood that were about 2’ long and 1-1 ½ inches thick were driven into the ground so that 4-5” remained above ground. The stakes were cut for ATEC specifically for the job. They were chosen for their species, size and even the location they were harvested from (lower slope/upper slope) so they would match the new environment as closely as possible. These measures insured that the establishment would be successful. If the installation is done with care, 90% of the installed stakes may grow well. Poor technique can result in 50-70% mortality.
